Devil's Slide/Hwy 1 Storm Repair

Daily Updates from Bijan Sartipi

Daily Update
May 25

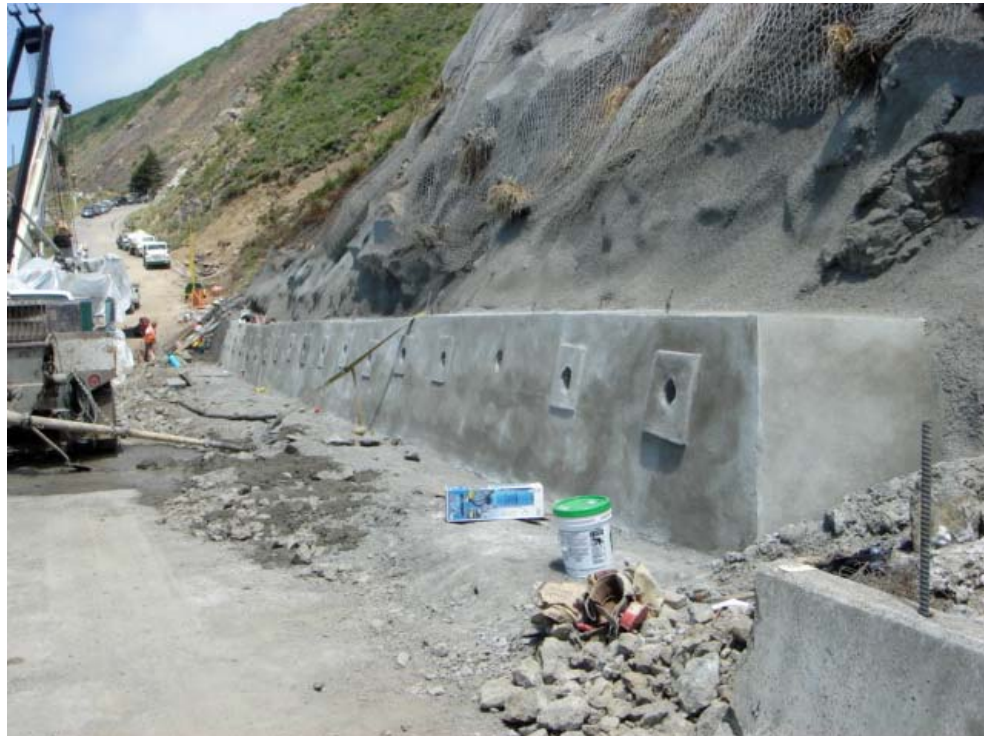
In the distance, crew finishes up at the northern end of the first of four whaler walls.

- Drill and install work for rock dowels continues. 159 out of a total 257 (62%) are now installed.
- Shotcreting whaler wall C continued to-day. Drilling for the 100 feet long tie backs will take place through the holes already cast into the wall. This is just one of four similar walls specified in the repair design, two above the road and two below. The concrete has to cure to a minimum strength before drilling for the tie backs can start. The schedule calls for tie back drilling to start next week.
